Manhole Inspection Summary

Manhole # S59G__018MH

Insp Date: **7/23/08 10:35 AM**

Location Address: **rear 300 oldham st**

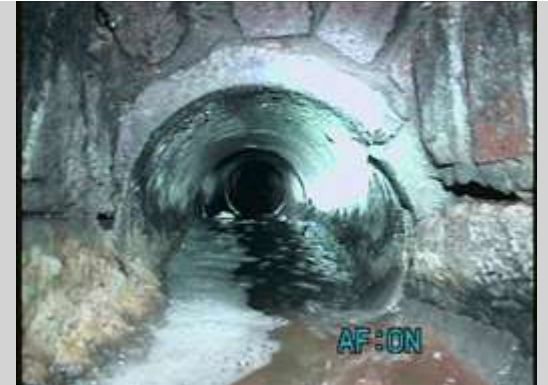
12 O'Clock Outflow

8 in. Circular Gravity Sewer
Pipe Out @ 12 O'Clock

Pipe Material: **Clay** ☐ Pipe Lined

Invert Depth: 6.50 (ft.) Flow Characteristics: **Fast**

Deposits: ☒ None ☐ Mud ☐ Sludge ☐ Debris ☐ Grease

Infiltration: **None** Pipe Seal Cond: **Unknown**

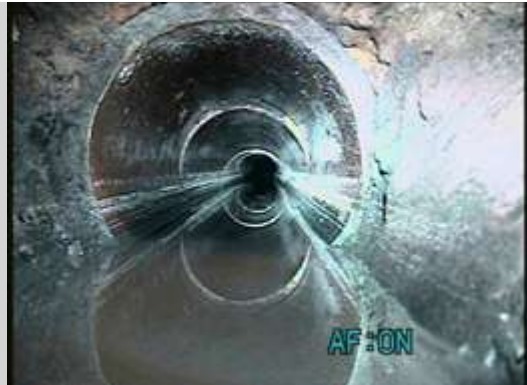
6 O'Clock Inflow

8 in. Circular Gravity Sewer

Pipe In @ 6 O'Clock

Pipe Material: **Clay** ☐ Pipe Lined

Invert Depth: **5.89** (ft.) Flow Characteristics: **Slow**

Deposits: ☒ None ☐ Mud ☐ Sludge ☐ Debris ☐ Grease

Infiltration: **None** Pipe Seal Cond: **Unknown**

Connects To: **Dead End**

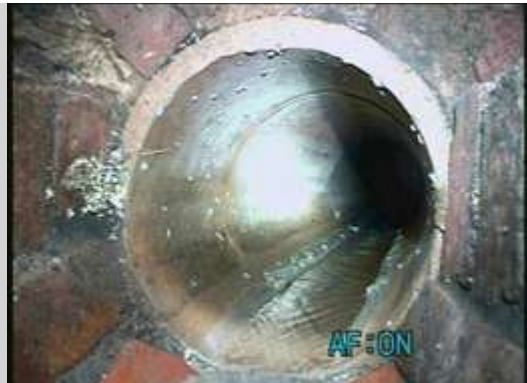
9 O'Clock Inflow

8 in. Circular Gravity Sewer

Pipe In @ 9 O'Clock

Pipe Material: **Clay** ☐ Pipe Lined

Infiltration: **None** Pipe Seal Cond: **Unknown**
